Flightfax

ARMY AVIATION
RISK-MANAGEMENT
INFORMATION

JANUARY 1999 ♦ VOL 27 ♦ NO 1

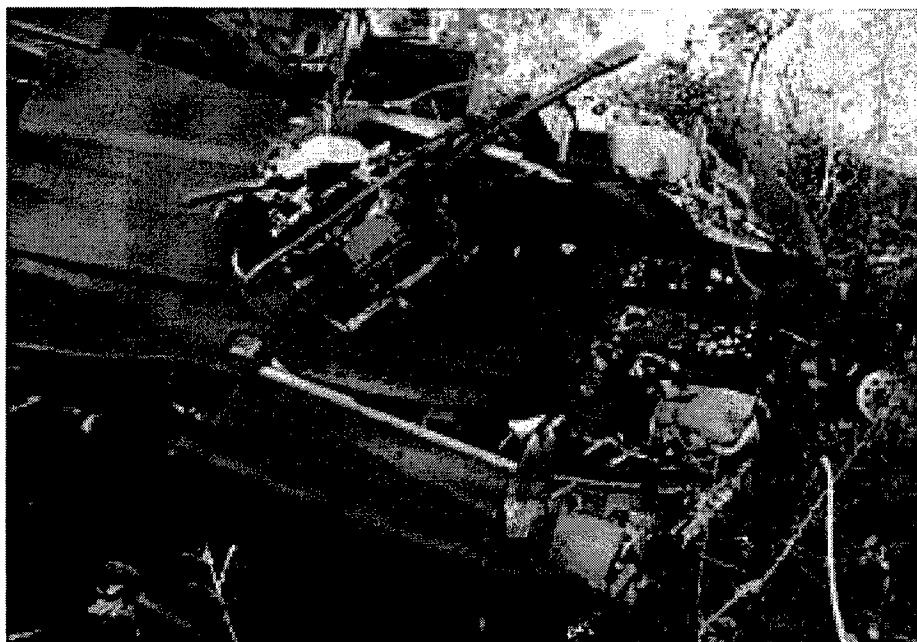
The gun ruptured, resulting in numerous rounds and large fragments penetrating the lower front fuselage, severing or damaging both mechanical and enhanced backup system (EBUCS) flight-control components. The aircraft descended out of control in a spiraling right turn until it hit the ground, resulting in extensive damage. The crew, fortunately, escaped injury.

ROUNDS AND FRAGMENTS SPRAYED UNDERSIDE OF FRONT FUSELAGE.

THIS GUN BARREL RUPTURED, RESULTING, IN EFFECT, IN AN APACHE SHOOTING ITSELF IN THE FOOT.

fail? Obviously, the gun will eventually reach a point at which the temperature will cause a misfeed, a lodged round, or other catastrophic failure. Indications appear as round dispersion and sinking round impact, all as the barrel heats and distorts. During the mishap described above, the 30mm reached an estimated 1939°F.

The fact is that the gun has limitations. The experts at Picatinny Arsenal and AMCOM are currently developing clear and quantifiable limits to be published in the appropriate sections of the operators manual. In the interim, Aviation Safety Action Message (ASAM) AH-64-99-ASAM-01 (011326Z Dec 98) recommends following the existing guidance with the warning: "Failure to adhere to the published gun duty cycle as described in the operators manual may cause a catastrophic failure to the 30mm gun, resulting in loss of aircraft, injury, or death."
